## INVENTORY FORM FOR STATE HISTORIC SITES SURVEY

Reed Leaverton Farm

QA-128

Orlando Ridout V, Historic Sites Surveyor

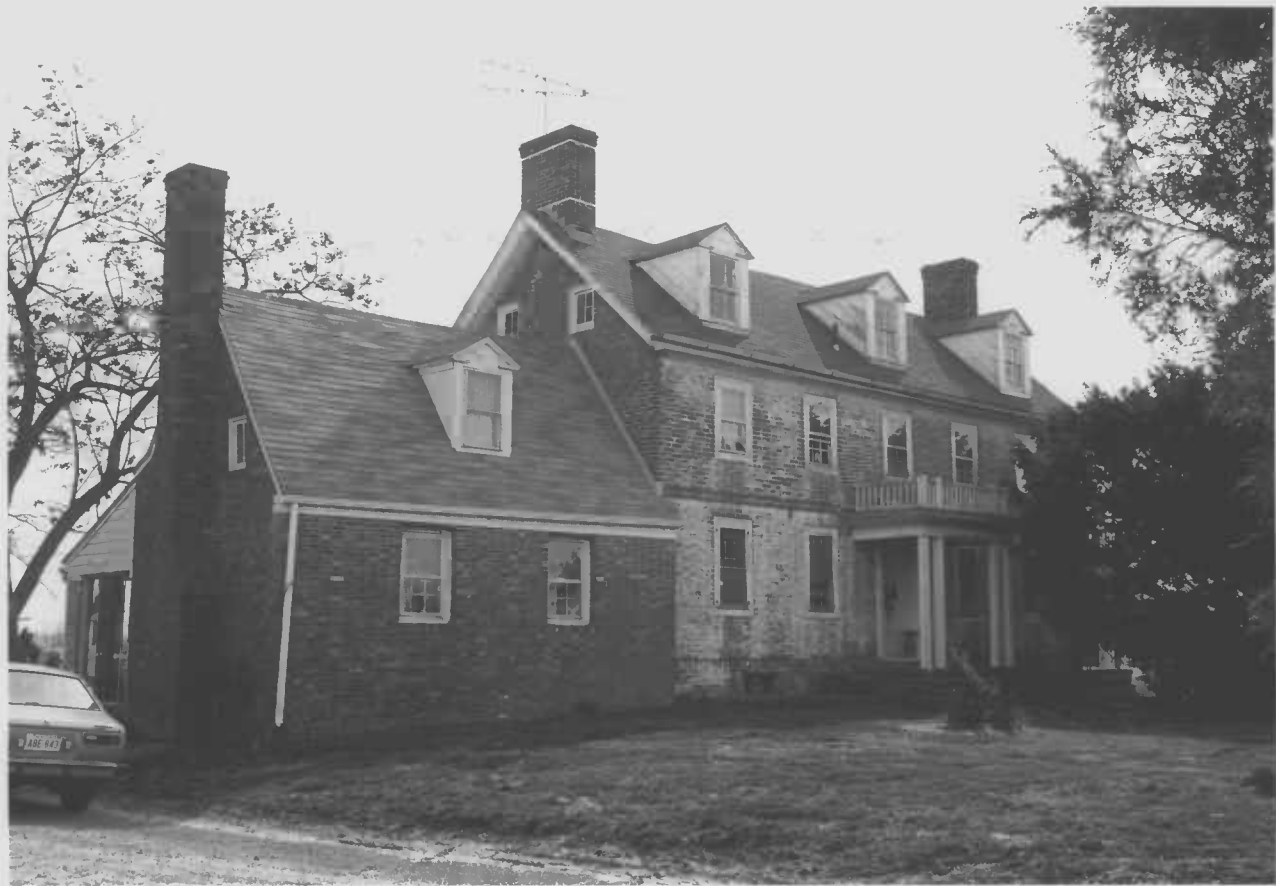
Front facade from Northeast

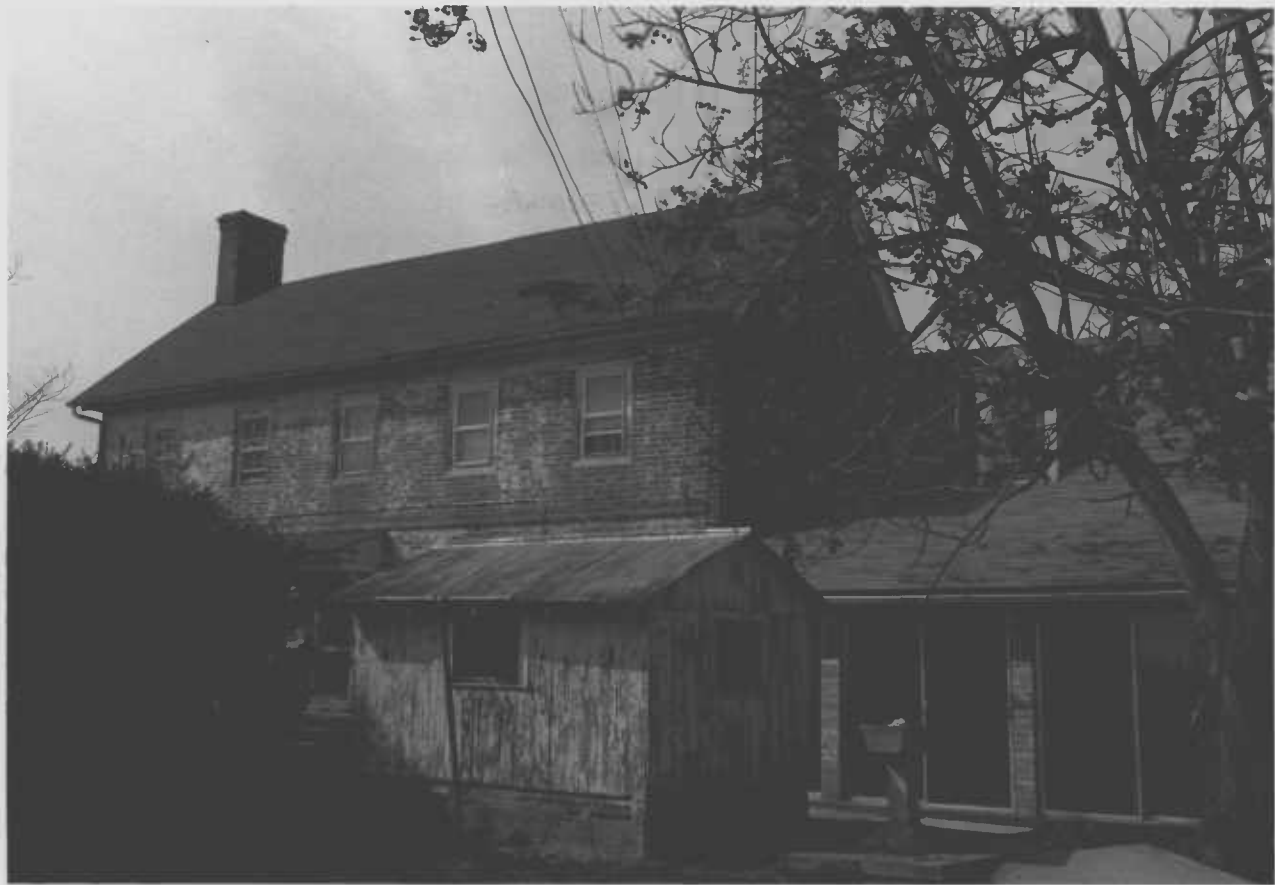
Rear facade from Southeast
